Manhole Inspection Summary

Manhole # S53K__022MH

Insp Date: **3/7/08 2:51 PM**

Location Address: **3212 fait**

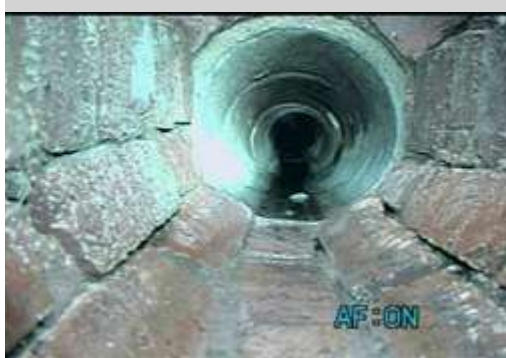
Defect 2

Condition: ☐ Sound ☐ Cracked ☐ Root Intrusion ☒ Deteriorated ☐ Leaks ☐ Debris

missing mortar in channel

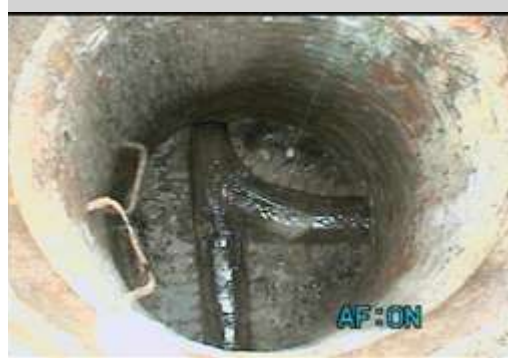
Defect 1

Infiltration: ☐ None ☐ Joint ☐ Cracks ☐ Mortar ☐ Roots ☒ Wall

Steps Count: **3** Missing: **0** ☒ Corroded

corroded steps, corbel infiltration

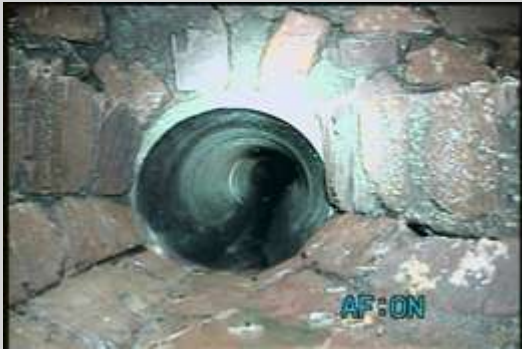
12 O'Clock Outflow

8 in. Circular Gravity Sewer
Pipe Out @ 12 O'Clock

Invert Depth: **8.33** (ft.) Flow Characteristics: **Slow**

Infiltration: **None** Pipe Seal Cond: **Unknown**

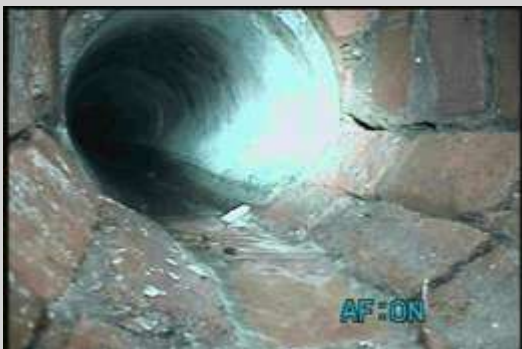
3 O'Clock Inflow

8 in. Circular Gravity Sewer
Pipe In @ 3 O'Clock

Invert Depth: **8.33** (ft.) Flow Characteristics: **Slow**

Infiltration: **None** Pipe Seal Cond: **Unknown**

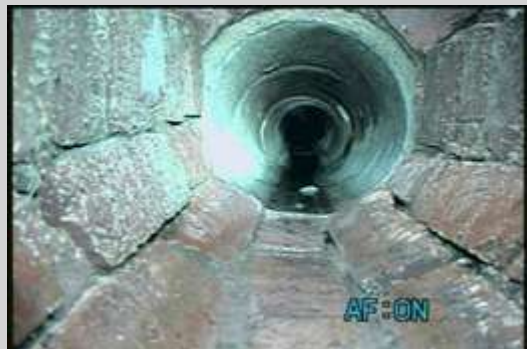
6 O'Clock Inflow

8 in. Circular Gravity Sewer
Pipe In @ 6 O'Clock

Invert Depth: **8.35** (ft.) Flow Characteristics: **Slow**

Infiltration: **None** Pipe Seal Cond: **Unknown**
